CONNECTICUT RIVER BASIN
BRADFORD, VERMONT

BLODGETT DAM
VT 00117

PHASE I INSPECTION REPORT
NATIONAL DAM INSPECTION PROGRAM

OCT, 1980

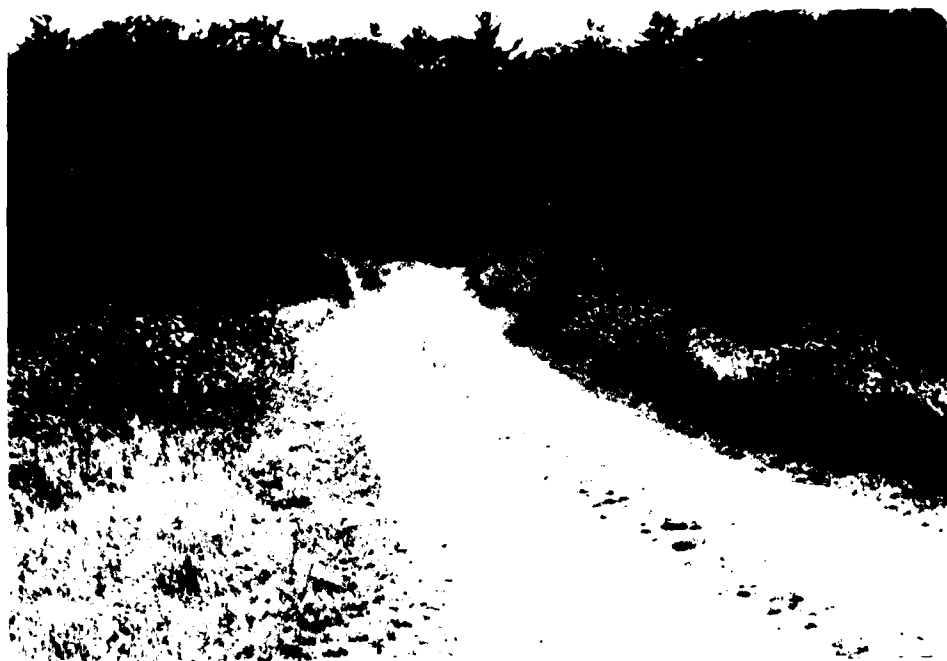
The crest of the dam is generally about 15 feet wide and has an unpaved roadway as shown in Photo 4. The crest is wider, on the downstream side, at the location of the natural knob. As shown in Photo 5, the downstream slope is covered with tall grass and brush and scattered small pine trees. Water was observed seeping from beneath the 18 inch diameter outlet pipe which exits at the downstream toe of the dam adjacent to the right abutment, seen in Photo 6. Clear seepage was observed downstream of the 6 inch diameter outlet pipe from the foundation drainage system as shown in Photo 7; a rust-colored pool of water, shown in Photo 8, was observed downstream from this seepage area. The SCS drawings for the Blodgett Dam indicate that a rock fill toe drain and blanket drain are located in the downstream toe of the dam at the location of the two seepage areas. The rock toe could not be discerned in the field.

(4) Crest of Dam, Looking Toward Right Abutment.

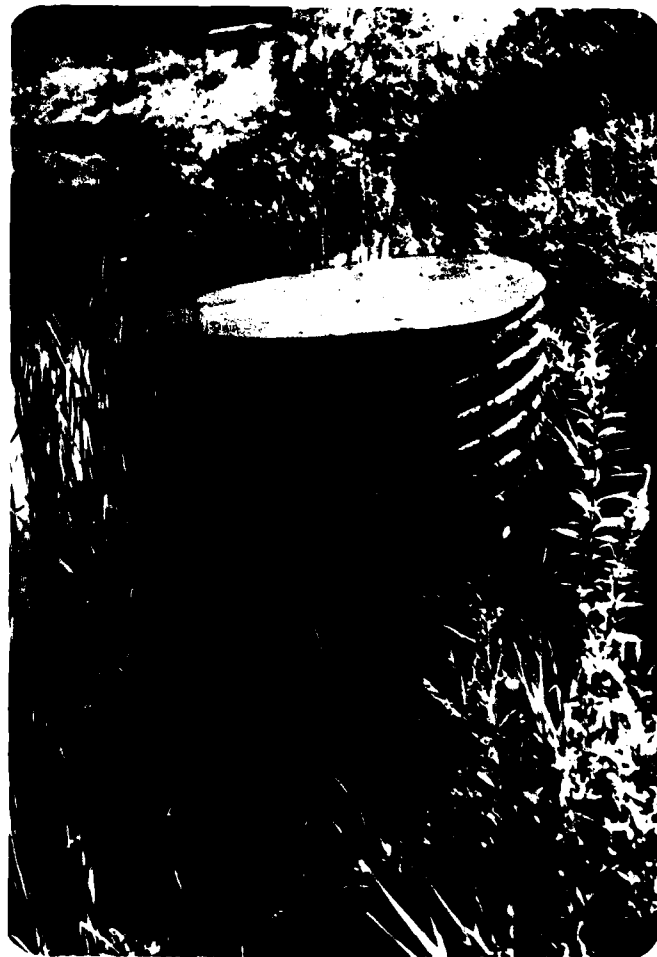
An 18" diameter low level outlet pipe passes through the dam and exits at the downstream toe of the dam at the contact with the right abutment as seen in Photo 6. The low level outlet is controlled by a slide gate housed in a steel well assembly on the upstream dam face as shown in Photo 12. The low level outlet appears in good condition and is reported operable.

(12) Low Level Outlet Gate Housing.

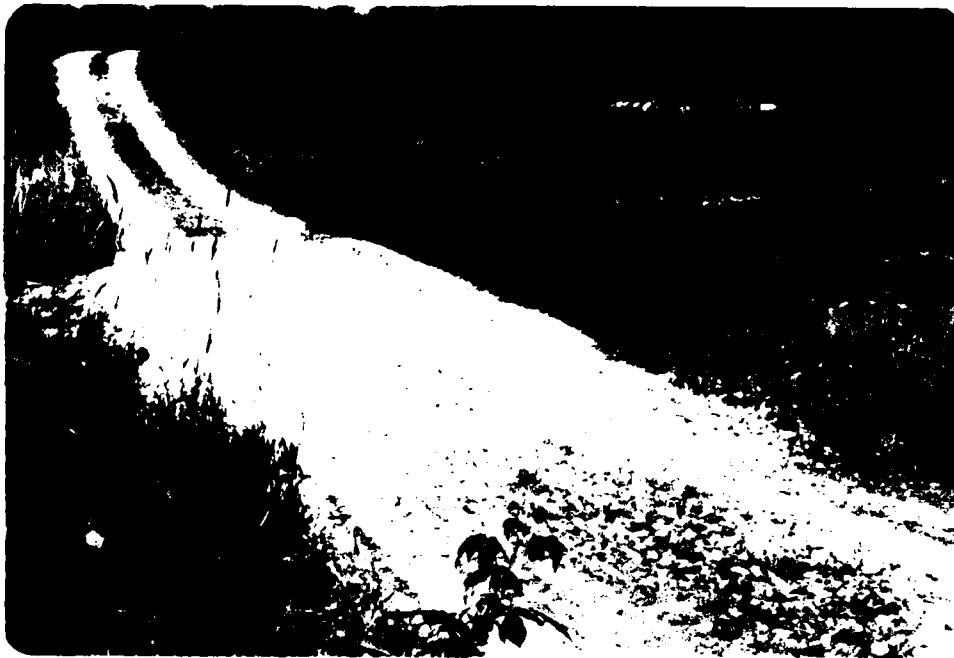
- a. General - The dam receives no regular maintenance. The crushed stone camp road crossing the spillway channel usually requires repair following the spring runoff.
- b. Operating Facilities - The low level outlet gate is reported in good condition. No plan for the periodic maintenance of operating facilities is known to exist.

(15) Roadway Across Spillway Channel.

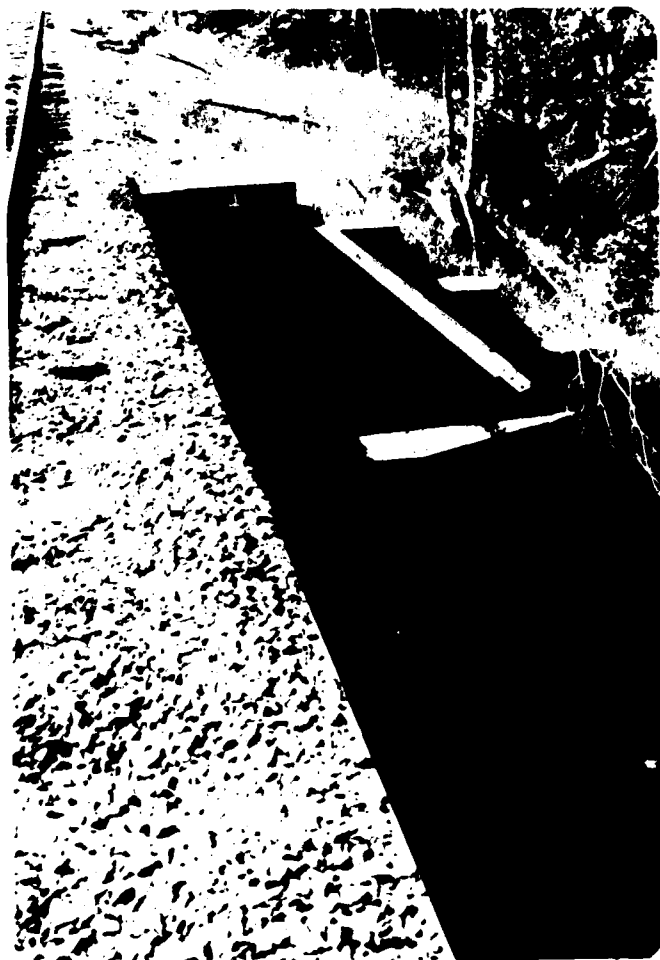
(18) November 4, 1927 Flood Level Marker (Disk) on Backwall of B & M Railroad Bridge Crossing Roaring Brook.
